Changes in Color Stability and Surface Roughness of Teflon-Coated Arch Wires After Clinical Use

Turk J Orthod 2022; 35(4): 260-267

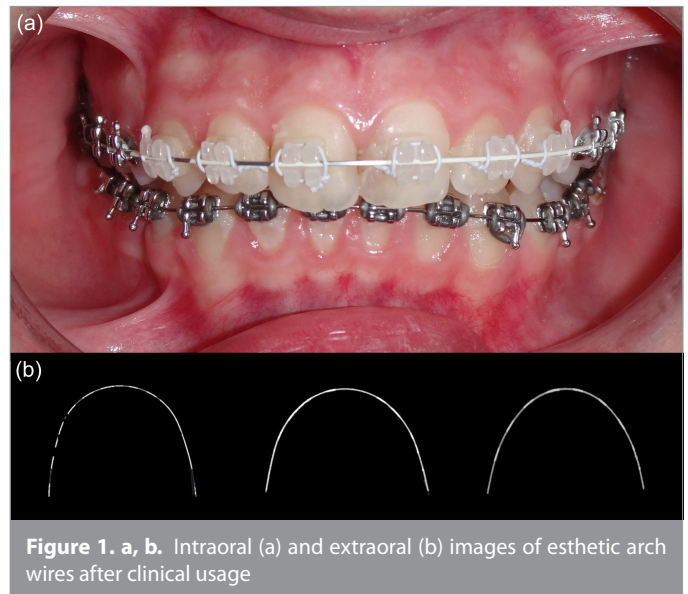
Figure 1. a, b. Intraoral (a) and extraoral (b) images of esthetic arch wires after clinical usage

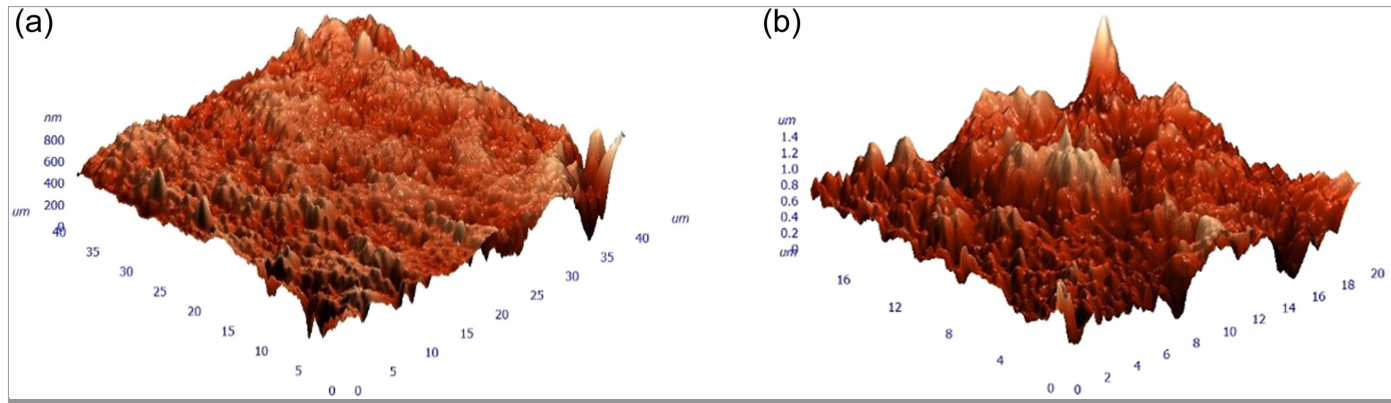
Mean Surface Roughness and Biofilm Adhesion
Comparison of the mean surface roughness values (Ra) of the as-received and retrieved wire samples are shown in Table 1. In all groups, the mean surface roughness values were statistically and significantly higher than the initial values. Three-dimensional images of a wire sample before and after clinical use are presented in Figure 4.

Figure 4. a, b. Atomic force microscopic three-dimensional images before (a, 40 × 40 μm) and after 4 weeks (b, 20 × 20 μm) of clinical usage
